IMMEDIATE VS. DELAYED LOADING AND AESTHETIC CONSIDERATIONS IN IMPLANT-SUPPORTED DENTAL RESTORATION – A CASE SERIES

Guy Levi, DDS (Los-Angeles, CA, USA)
Vladislav Dvoyris, DMD (Tel-Aviv, Israel)
Dana Levy (Jerusalem, Israel)

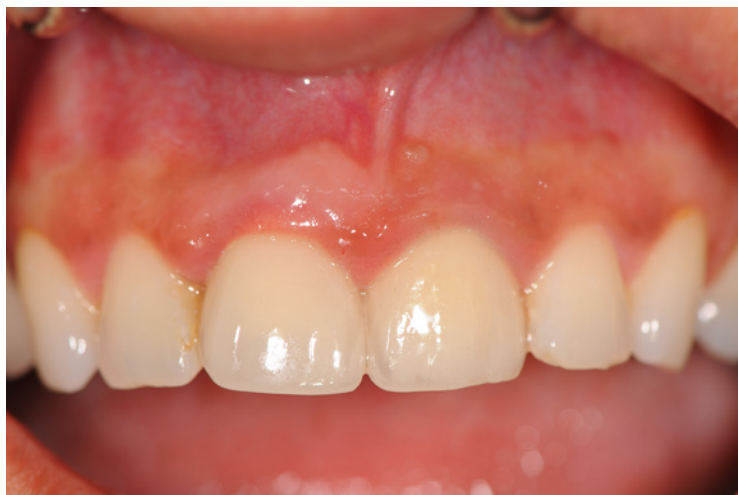
Figure 1:

A 35-year old generally healthy female arrived at the clinic, complaining of constant dislocation of a permanently cemented crown on tooth #1.1 (#8). Note the gingival inflammation around 1.1-2.1, caused by insufficient brushing – as the patient feared that brushing may remove the crown once more. Heavy smoking was an additional factor in the gingival inflammation and mediocre oral hygiene status presented at admission.

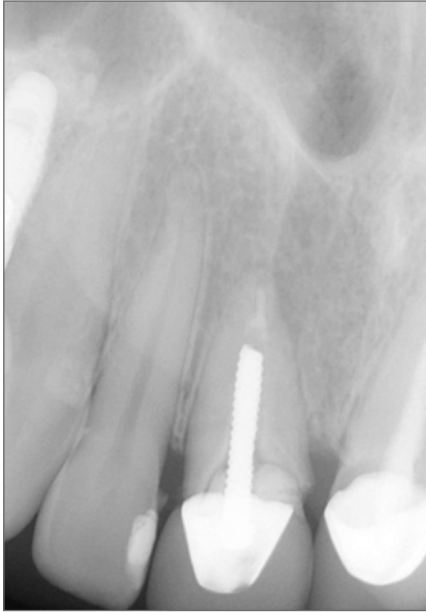
Figure 2:

A pre-operative X-ray shows a failing post-and-core structure on tooth 1.1, and a similar clinical picture in 2.1 (#9). The treatment plan accepted by the patient included:

- Removal of both 1.1 and 2.1 crowns
- Extraction of 1.1, socket preservation and delayed implantation, while 2.1 will serve as a temporary abutment tooth for a 1.1-2.1 cantilever bridge.
- Extraction and immediate implantation in 2.1, and restoration with Zirconia crowns.

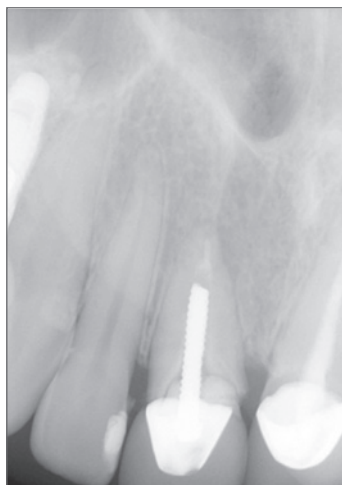
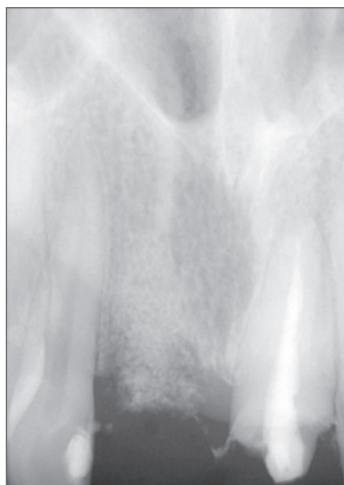
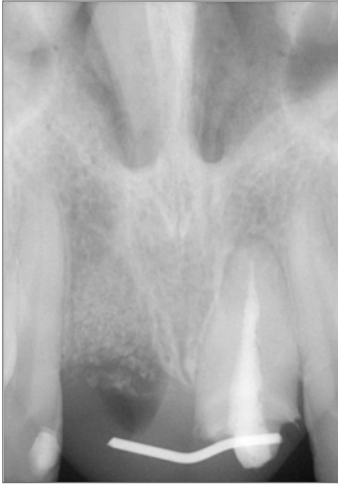
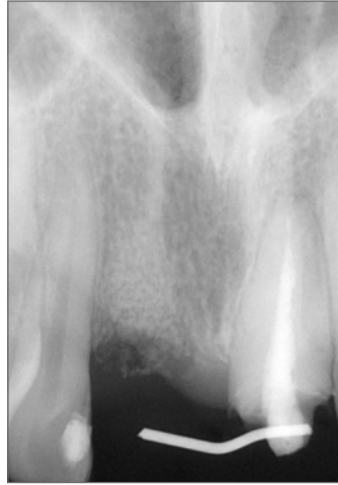
Figure 6 a,b,c,d:

Follow-up X-rays were performed at two and three months post-surgery. Note the excellent bone remodeling achieved by using a dentine autograft.

- a. Diagnostic X-ray
- b. Post-operative X-ray
- c. Follow-up 2 months post-surgery
- d. Follow-up 3 months post-surgery

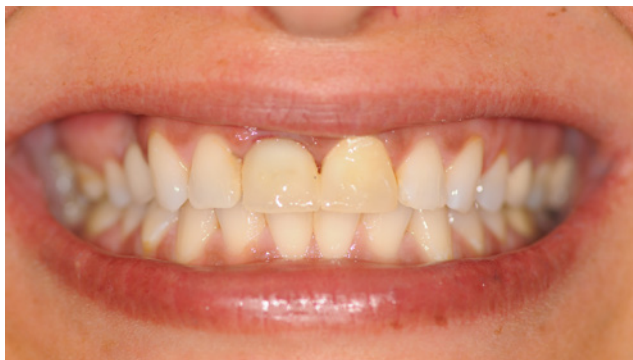
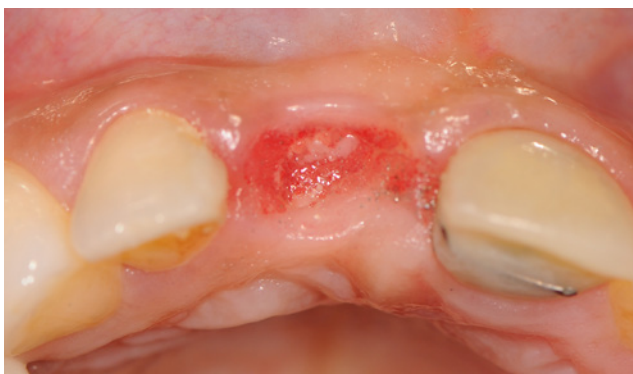
Figure 7 a,b:

Note that the use of a cantilever bridge, diminishing the occlusal stress, allowed the gingival tissue to grow coronally, which later provided an optimal soft-tissue support for the implant and the restoration.

After 3 months the bridge was removed, and the cantilever part was separated. The retaining part was placed on tooth #2.1 as a single temporary crown.

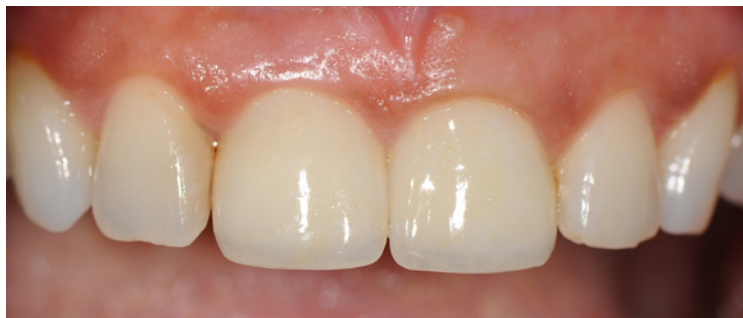
Figure 12:

At a follow-up examination after 18 months, the patient is satisfied. The crowns are intact and show excellent aesthetics and gingival health.

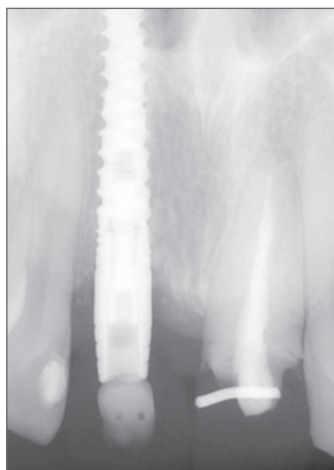
Figure 13 a,b,c,d:

- a. Day of surgery and immediate loading
- b. Follow-up at 1.5 months post-implantation (with a temporary abutment and crown)
- c. Follow-up at 4 months – following cementation of a permanent crown
- d. Follow-up at 18 months – note the excellent mineralization of the cortical plate, demonstrating excellent fit of the prosthetic assembly and peri-implant health.

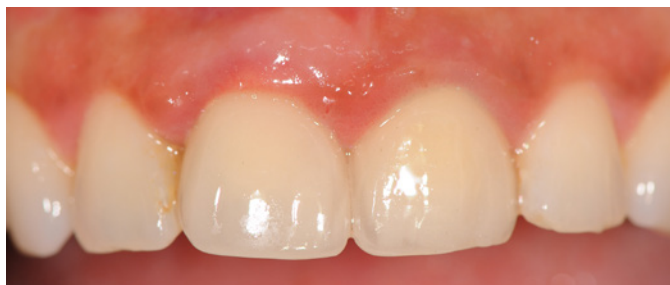
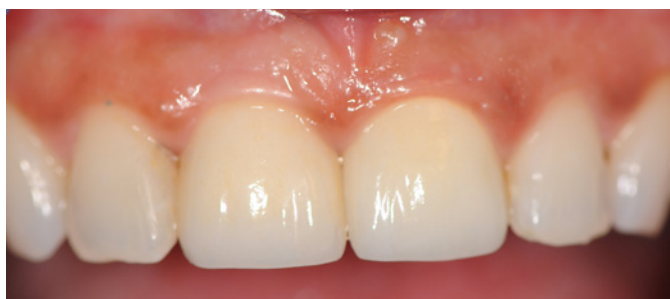
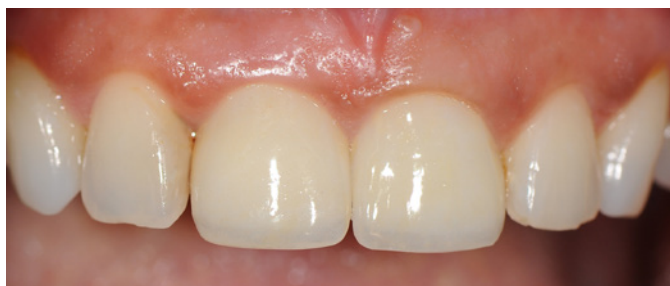
Figure 14 a,b,c:

- a. Diagnostic photo at admission – initial state
- b. At 4 months post-implantation – fitting of permanent crowns
- c. 18 months follow-up

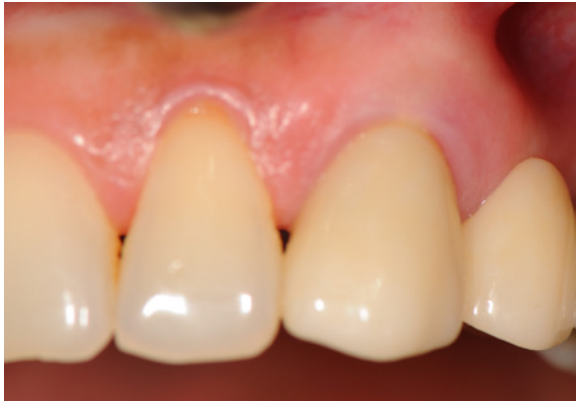
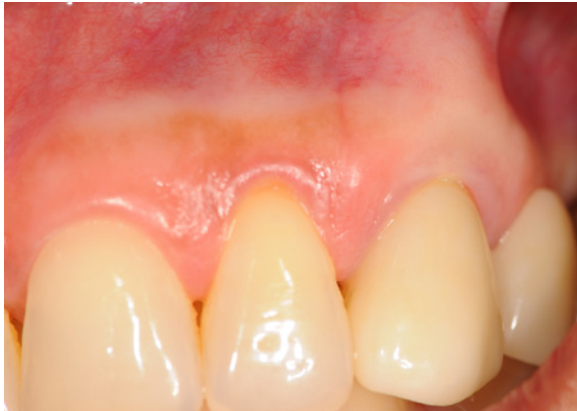
Figure 1 a,b:

A 45-year old, generally healthy female, complained of a dislodgement of a crown from tooth #2.3 (#11).

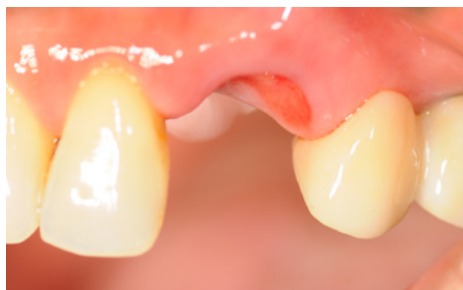
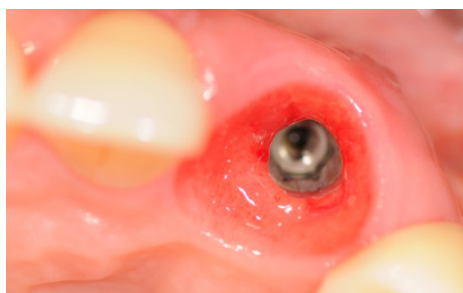
Figure 6 a,b,c:

Three months after the operation, the temporary crown was removed. Note the excellent gingival profile, created thanks to the favorable implant position, abutment contour and the bone grafting during the implant placement.

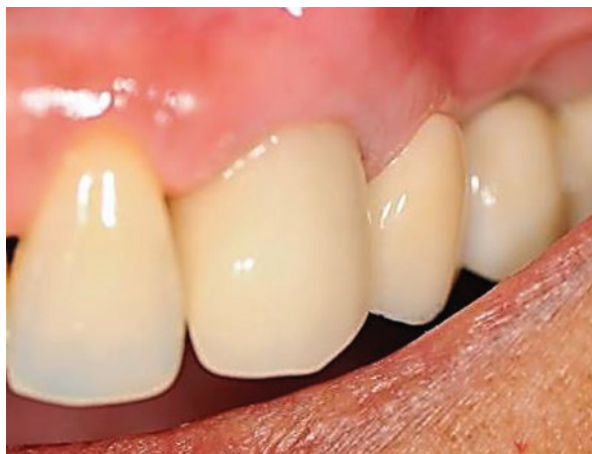
Figure 8 a,b:

At a 15-months post-operative follow up, the crown and implant are intact. Note the stabilization of the bone level around the 2.3 implant as well as an acceptable appearance of gingival papilla in between 2.2-2.3.

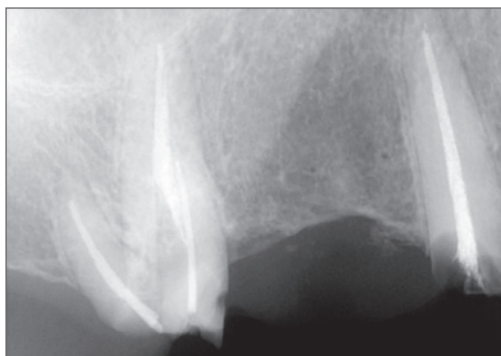
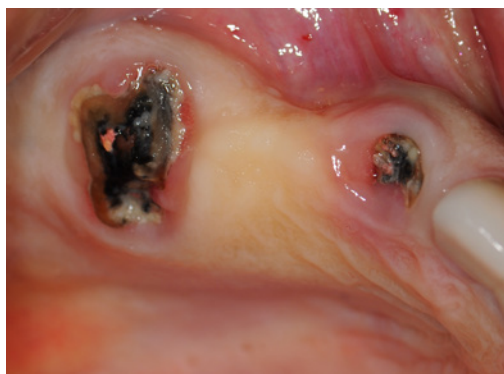
Figure 1 a,b:

A 54-year old generally healthy, non-smoking and vegetarian male, arrived at the clinic complaining of fractured teeth in the upper right maxillary region.

Teeth #1.6 (#3) and #1.3 (#6) were deemed hopeless, and the treatment plan included their extraction, combined with simultaneous implant placement in the area of #16,15,14 with immediate loading. In the 1.3 site, due to lack of available buccal bone and to prevent the risk of recession, socket preservation and delayed implant placement were planned.
