Full-Arch Implant Supported Rehabilitation with Screw-Retained Hybrid Prothesis and Implant Bar Overdenture

Guy Levi, DDS (Los Angeles, CA, USA)
Vladislav Dvoyris, DMD (Tel-Aviv, Israel)

CASE I

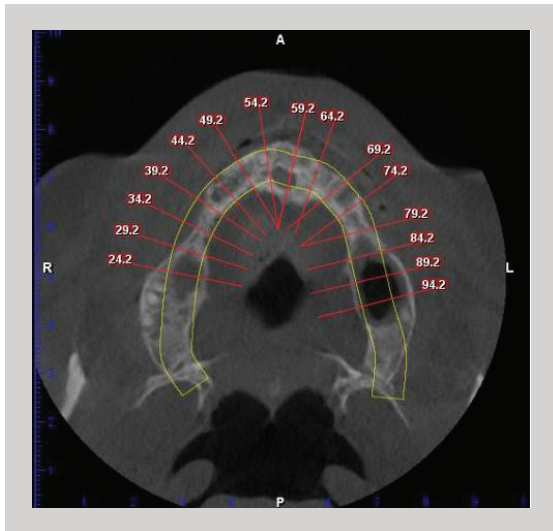
Note the angulation of the remaining alveolar ridge. Since a screw-retained hybrid prosthesis was planned, angled multiunit abutments were used in the restorative stage to improve implants restorative position when needed.

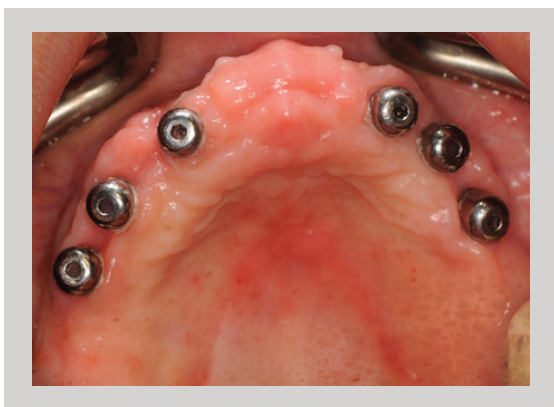
Six Ditrón MPI (3.5mm platform) implants were placed, combined with a closed bilateral sinus augmentation and horizontal ridge augmentation, using DBM graft (OsteoDemin, Implants Ltd., USA) And a synthetic HA (Osteogel. Implants Ltd., USA).

Sinus augmentations were performed using Osteogen only.

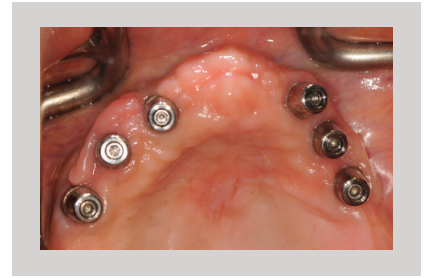
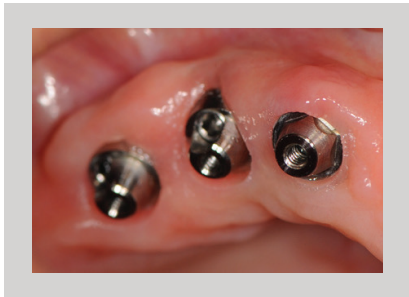
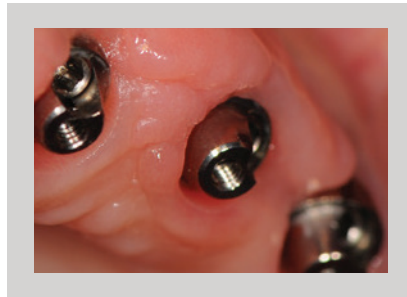
Figure 5 a,b,c,d,e:
Note the exposed buccal part of the angulated multiunit at position 2.5 – usually, such an exposure may cause an aesthetic concern. However, in this case, the low lip line of the patient rendered this tissue deficit unnoticeable. The patient accepted this aesthetic disadvantage.

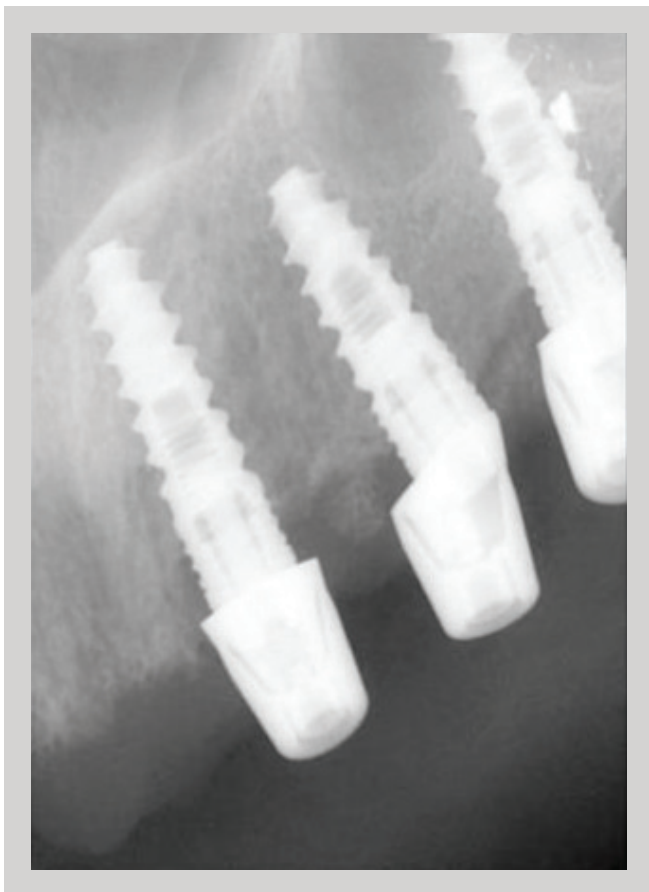
Figure 6 a,b:
X-ray following placement of the multiunit abutments.

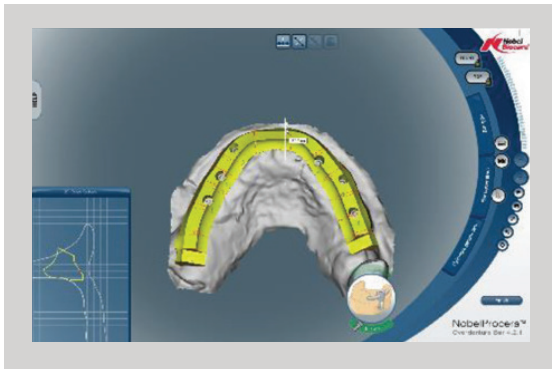
A final impression was taken, and the stone model, together with a clinically approved diagnostic wax-up were sent to NobelProcera CAD/CAM Services Center.

Please observe a diagnostic wax-up driven planning of the titanium frame.

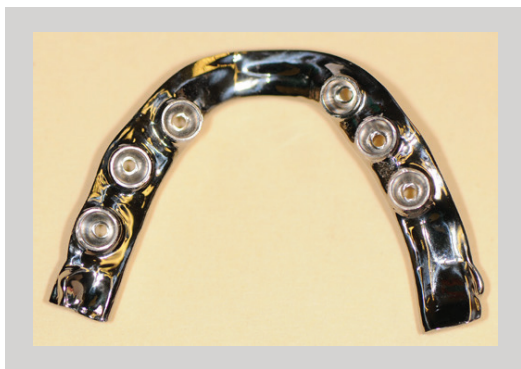
A milled titanium bar (Nobel Procera, NJ, USA) was created in accordance with the CAD planning. The bar was scanned again, and a zirconia superstructure, including teeth, was milled.

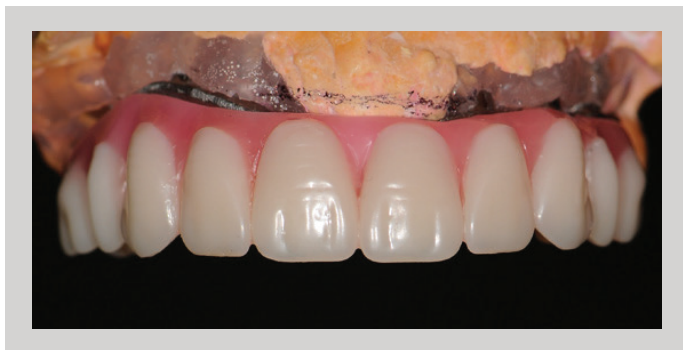
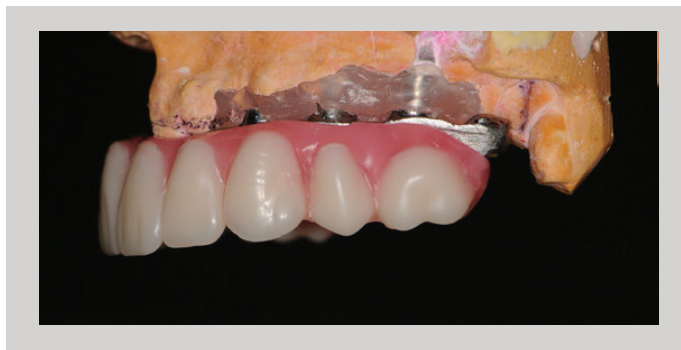
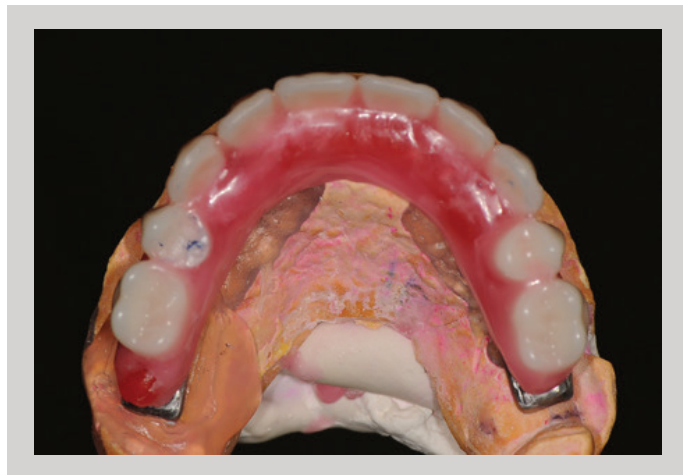
Figure 9 a,b,c:
Try-in with model teeth and wax on the titanium bar.
The try-in was fitted on the model and in the patient's mouth, and later scanned to serve as a template for the final restoration.

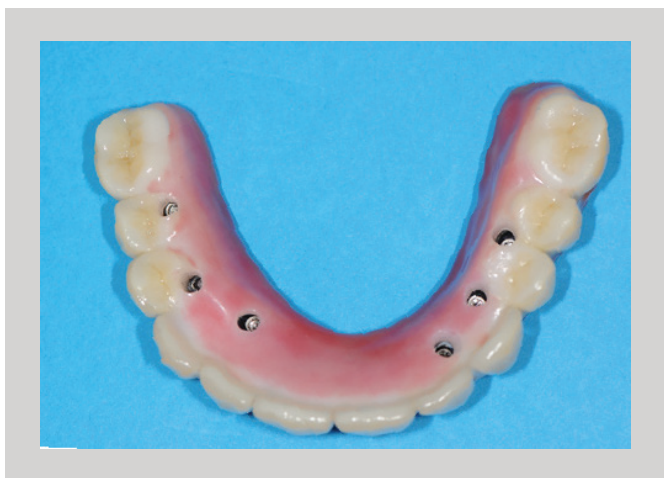
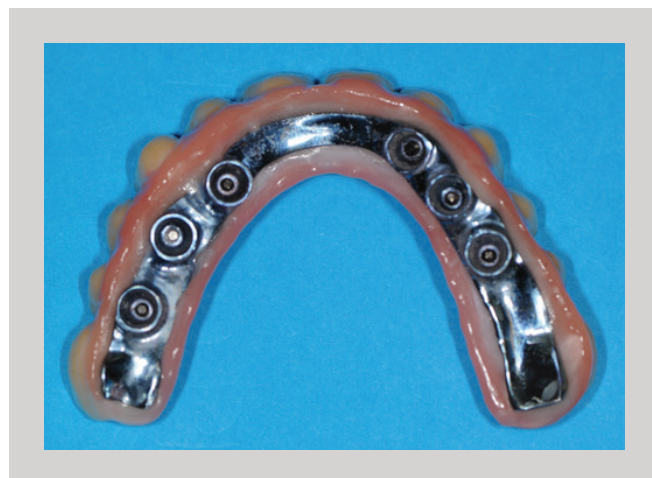
Figure 10 a,b:
The final zirconia prosthesis was milled and cemented with composite to the titanium bar. Note the screw locations – the angled multiunit abutments allow alteration of the screw axes.

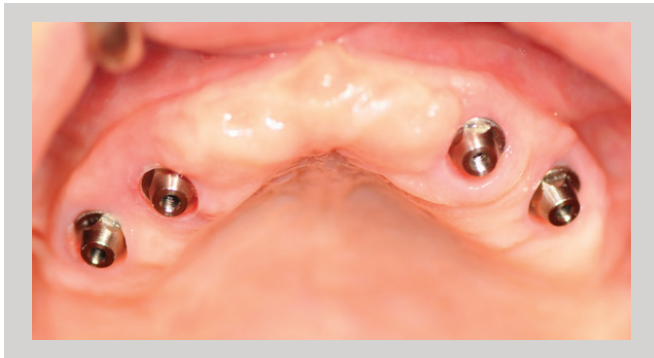
Figure 4

Four straight multiunit abutment were installed 1 month after implants uncovering, and screwed in with a torque of 30 Ncm. There was no need in fixing the angulation of the alveolar ridge in this case, as the treatment plan here included a bar, upon which a complete removable denture will be placed.

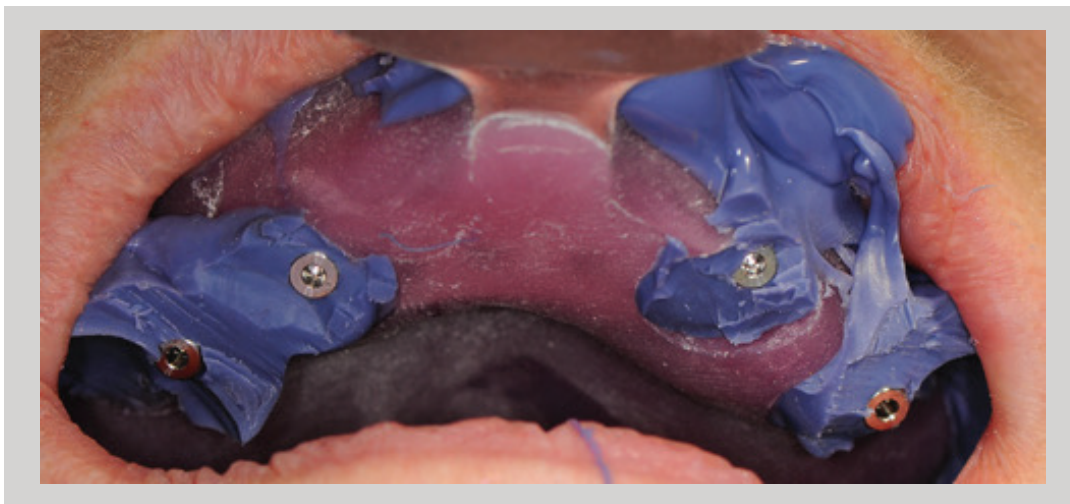
Final impressions were taken using an open tray technique, and analogues were connected.

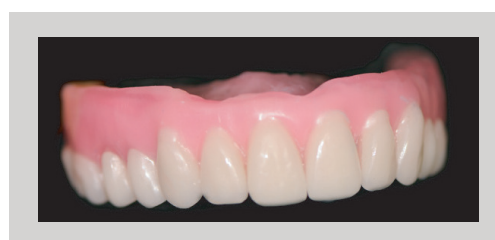
A master model with a diagnostic tooth set up was sent to the lab, to create a milled titanium bar (NobelProcera CAD/CAM Services).

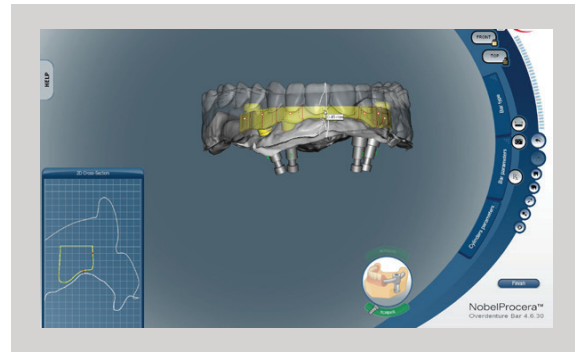
Figure 8 a,b:
Titanium bar planning before milling.

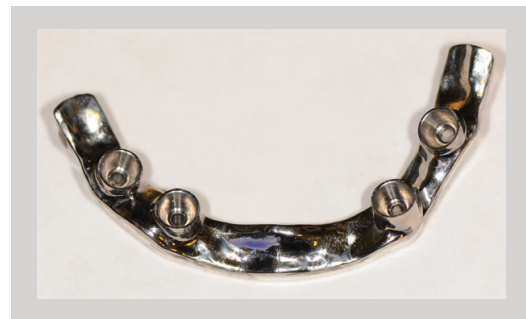
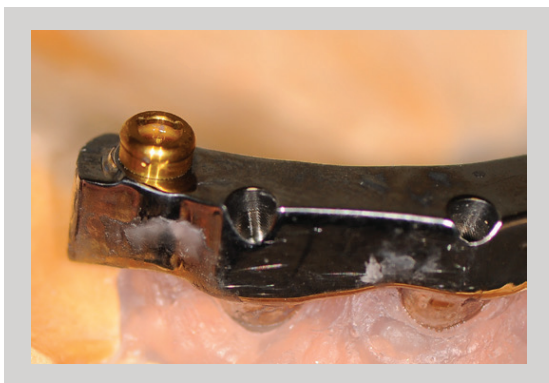
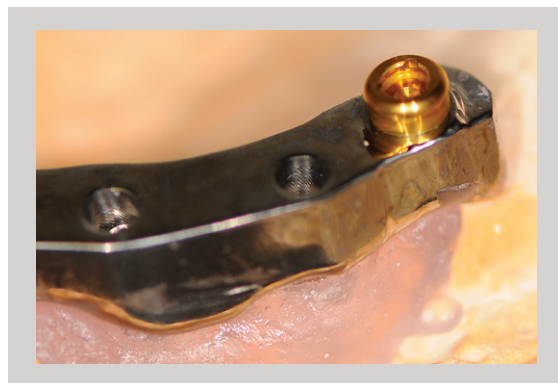
Figure 9 a,b,c,d:
A titanium bar was milled (NobelProcera CAD/CAM Services).

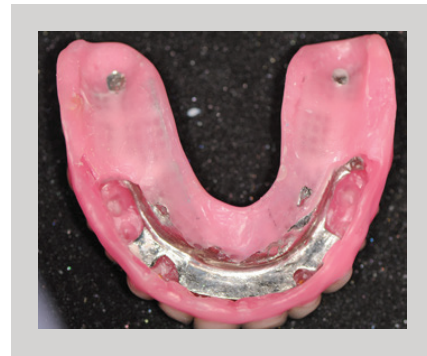
Final try-in of the metal bar and the temporary prosthesis. Note the cast metal frame in the interface of the prosthesis with the bar.

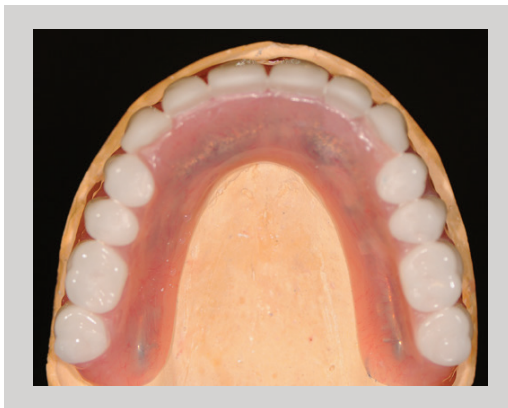
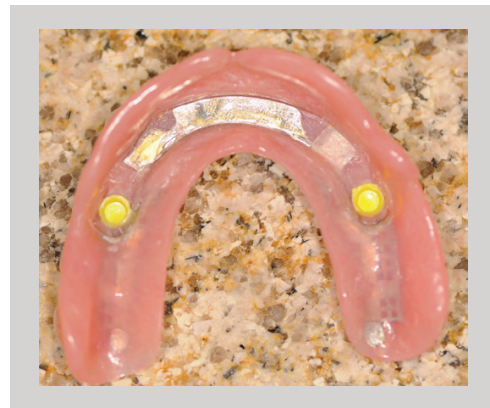
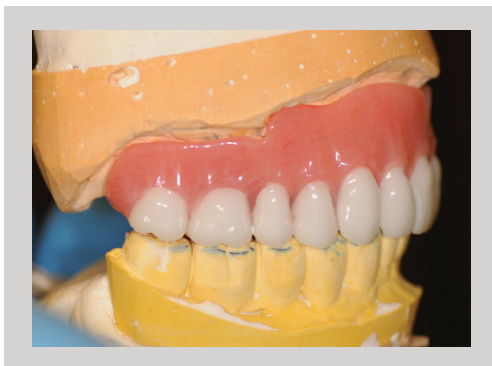
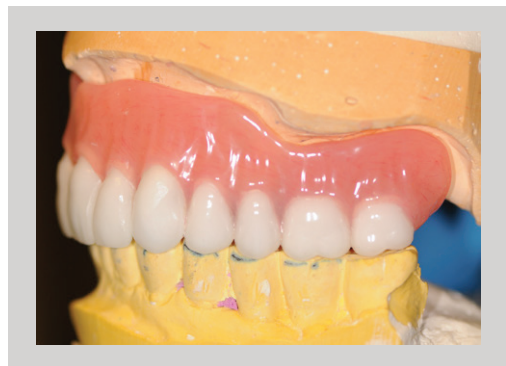
The final prosthesis. Note, that upon the patient demand porcelain teeth were used in the prosthesis, despite their relative hardness and weight. Nevertheless, porcelain teeth also have an advantage, as they suffer minimal attrition and thus allow for a much better control of the occlusion in the long term. Note also the pronounced facial flange of the prosthesis (see Fig. 13).

With the assistance of the new denture, we have succeeded in recreating the vertical dimension of occlusion, while the pronounced facial flange of the denture (*Fig. 11*) allowed for proper lip support, to the utter satisfaction of the patient.

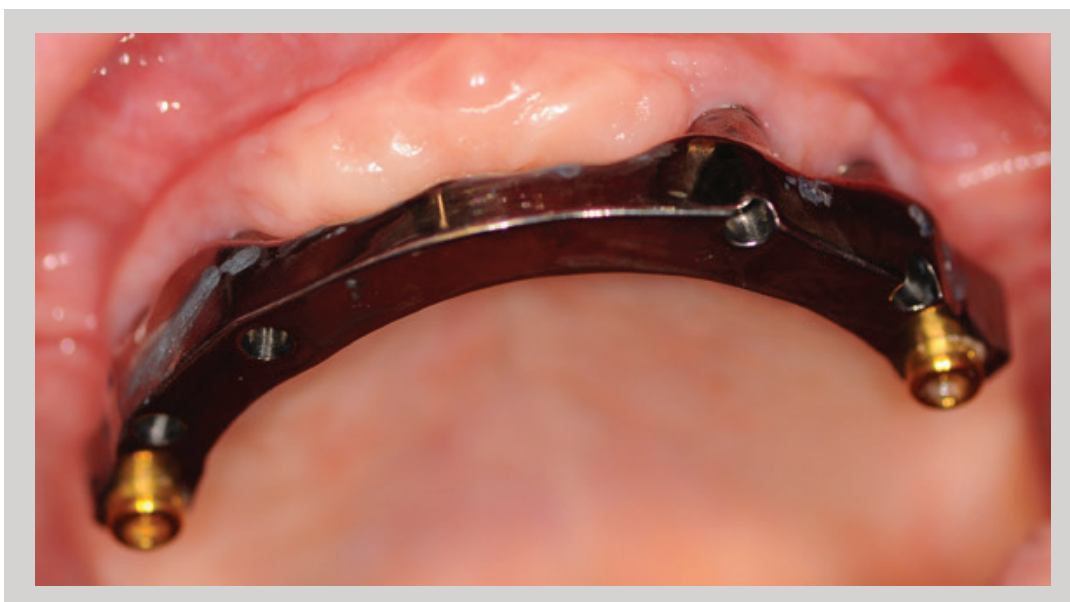
A milled titanium bar was delivered, and connected to the multiunit abutments with a 20Ncm torque.

Observe the stable bone interface surrounding the implants.

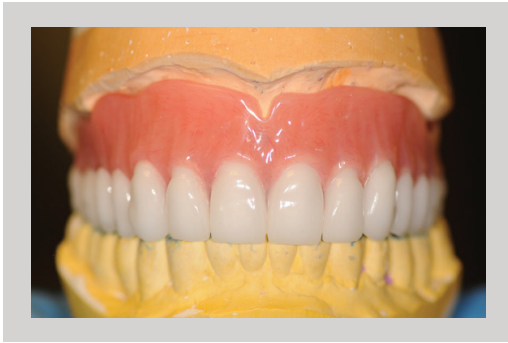
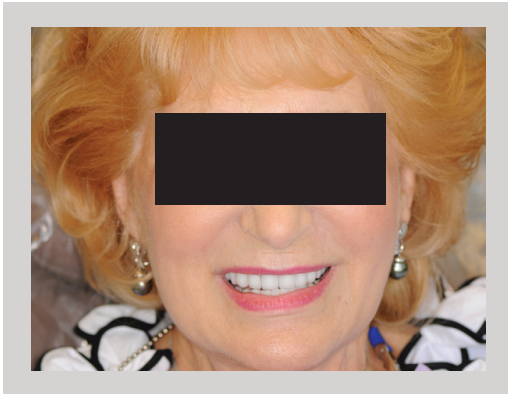
Figure 14 a,b,c:
The final restoration on the model,
while the bar is connected to the
implants. After delivery, the **patient is
extremely happy.**
